Docket No. 217 – Development and Management Plan Inspection

Northeast Utilities Service Company Certificate of Environmental Compatibility and Public Need for the construction of a 345-kV electric transmission line and reconstruction of an existing 115-kV electric transmission line between Connecticut Light and Power Company's Plumtree Substation in Bethel, through the towns of Redding, Weston, and Wilton, and to the Norwalk Substation in Norwalk, Connecticut.

Date: December 22, 2005

Location: Overhead Line (Composite 345kV and 115kV Gallows Hill to Archers Lane) and (345kV H-Frame Hoyts Hill to Gallows Hill)

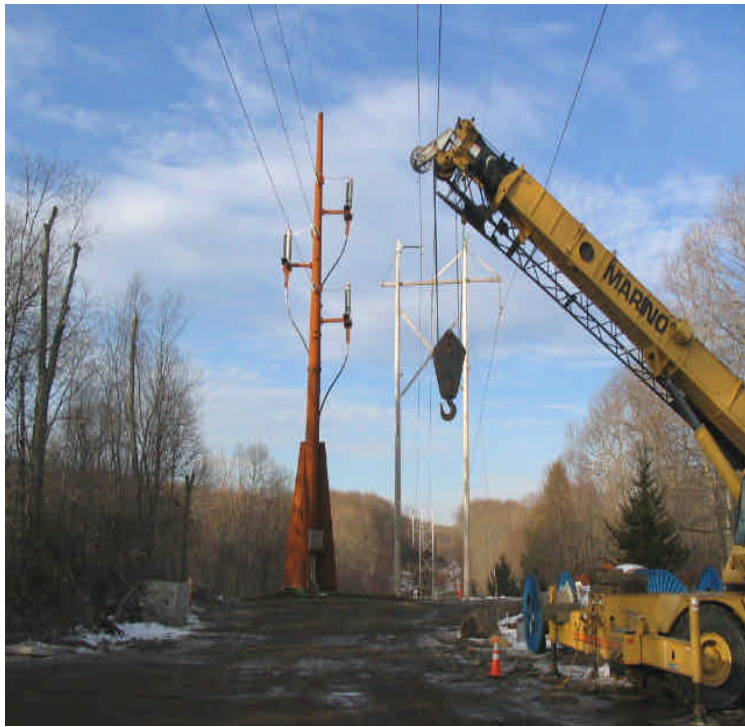
(Composite Section): Photo on the left shows the 1st structure off Gallows Hill with all scaffolding removed and structure work complete. Photo on the right shows some minor clearing needed along the access road. 12/22/05

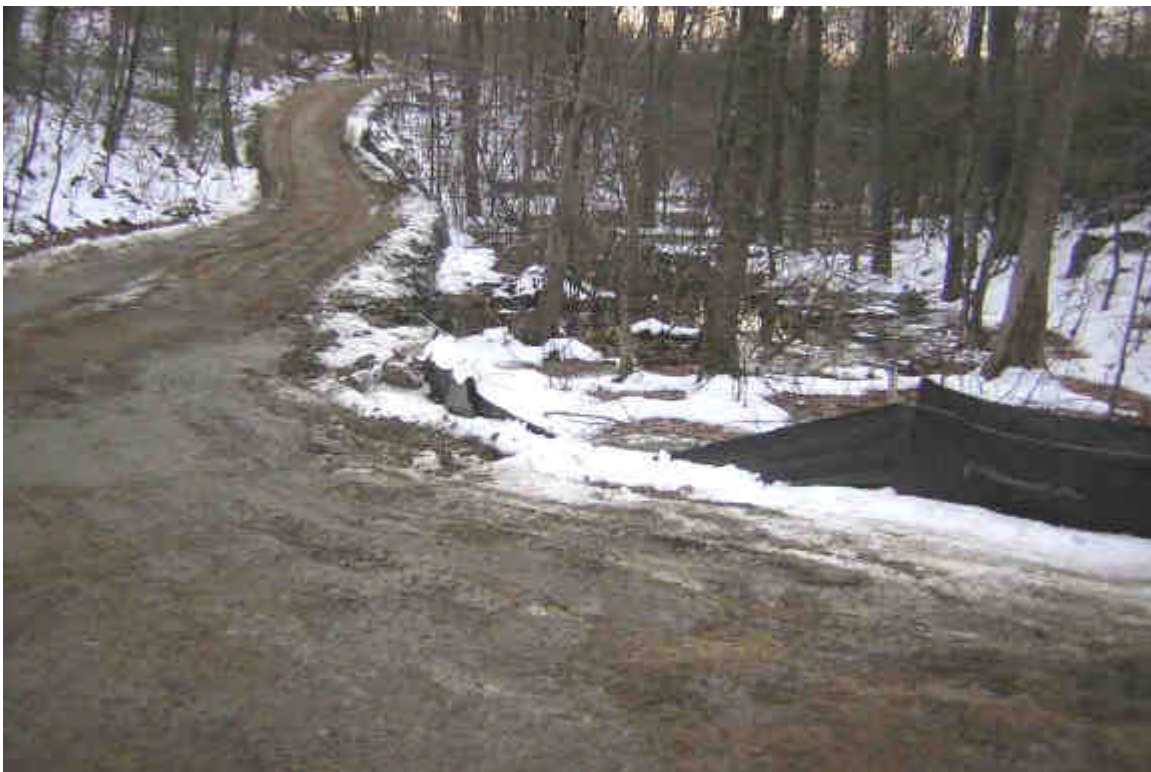
View of the access road near a low wetland area on the Archers Lane side. The silt fence is partially down and should be repaired. 12/22/05

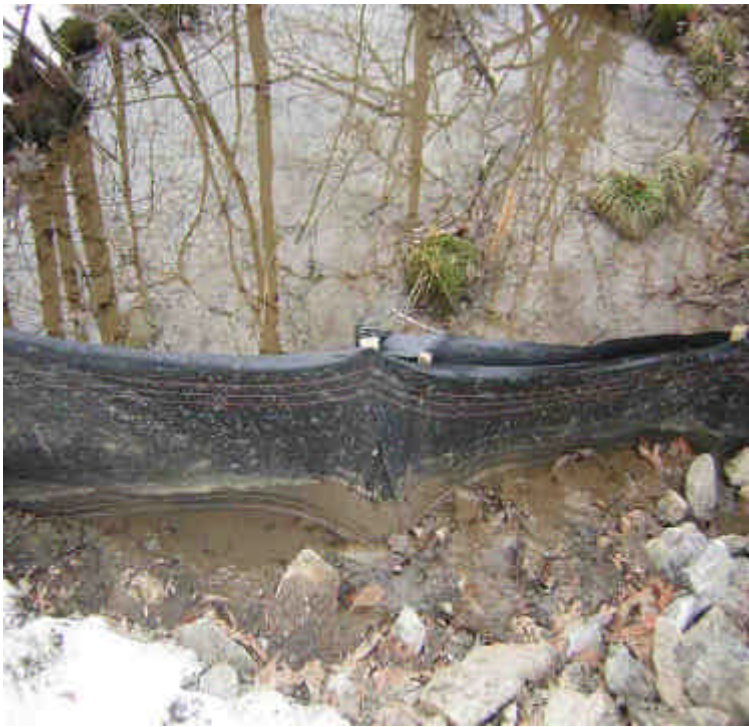
<p>Erosion and Sediment Controls (includes inspection within 24 hours of a storm event)</p> <p>Erosion and Sediment Controls</p> <p>Composite</p>	<p>-Water has been flowing through/under the silt fence at the wetland crossing near Archers Lane. Turbidity was noted here. Silt fence should be extended where needed or toed in properly. 12/01-12/22/05. The area is not frozen at this point. 12/22/05</p> <p>- The ROW and roads had been very muddy but are now mostly frozen. 12/22/05</p> <p>- The 2nd structure in from Gallows Hill has had a bare soil/boulder slope adjacent to the wetland with controls still well in place. 11/23-12/22/05.</p> <p>- The sediment which drained to the wetland area is still present under the snow. This</p>	<p>- The silt fence should be extended, towed in, and/or repaired as necessary. When maintained, the silt fence does a very good job of keeping turbid water out of the wetlands. The controls should be repaired during thaw periods. 12/8-12/22/05.</p> <p>- Additional stability measures may be needed on the access road for equipment movement during thaw periods. 12/8-12/22/05</p> <p>- The area should be regraded, pulled back from the fence, and restored when feasible due to weather. 12/1-12/22/05</p> <p>- The sediment was not scraped up and removed prior to snow cover and is now</p>

Photo on the left is the low wetland crossing near Archers Lane where turbid water has been able to move under the fence to the wetland beyond. Photo on the right is looking at some snow plow issues where sediment was pushed over the silt fence. 12/22/05

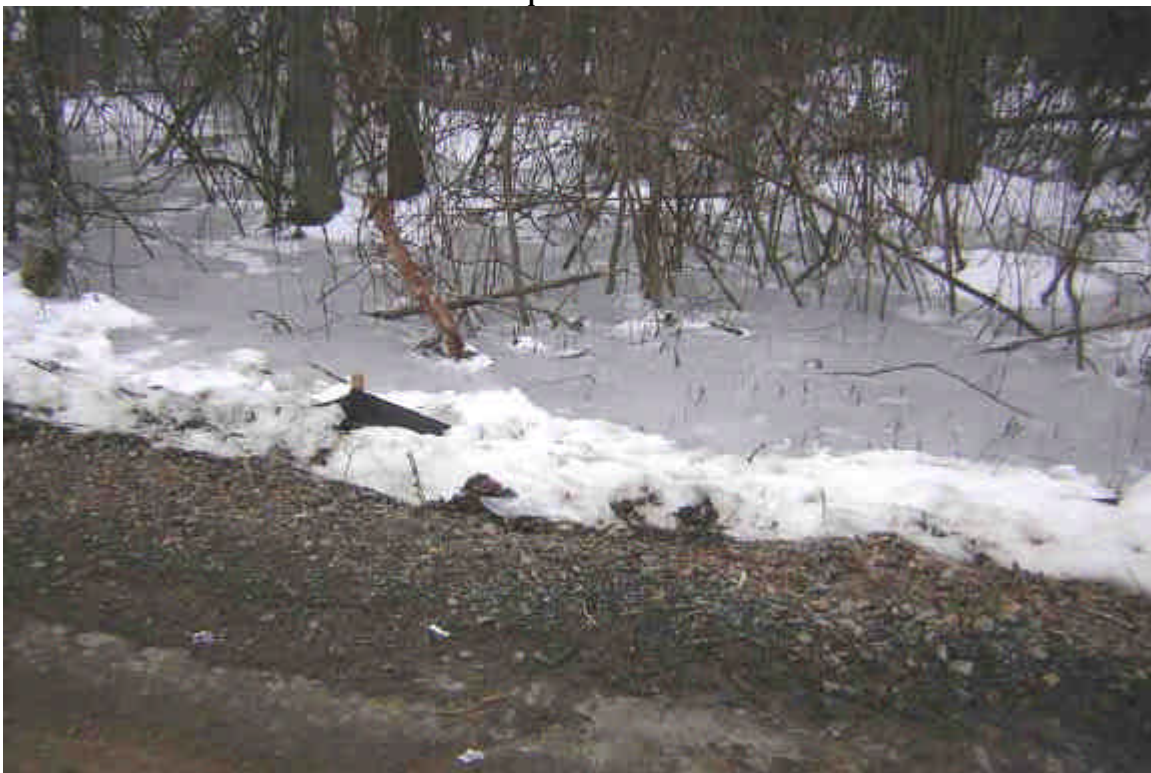
Photo on the left shows a close up of another wetland crossing where the silt fence was overwhelmed/pushed down and needs repair. 12/22/05

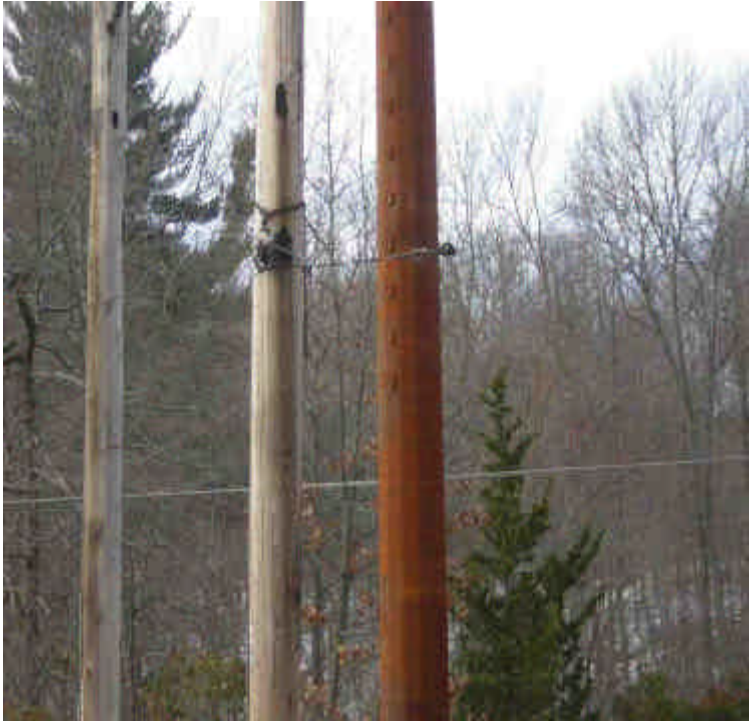
Photo on the left shows preparation to remove an existing wood pole along the ROW. Photo on the right is of the (345kV H-frame section) looking along the ROW from Chestnut Ridge. A timber mat bridge was installed over a stream/wetland area. 12/22/05

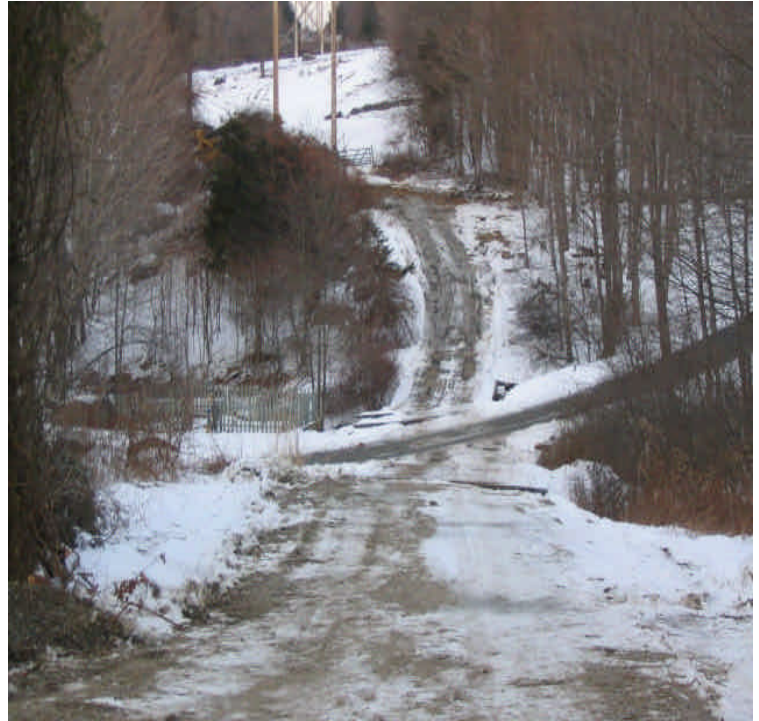
345kV H-Frame	- Work recently started on Section 1 between Hoyts Hill and Gallows Hill Rd. An access road has been constructed off Chestnut Ridge Rd and includes mats placed to cross a stream and wetlands. Use of a private	- The road appears to be stable and the crossing was well installed. 12/22/05

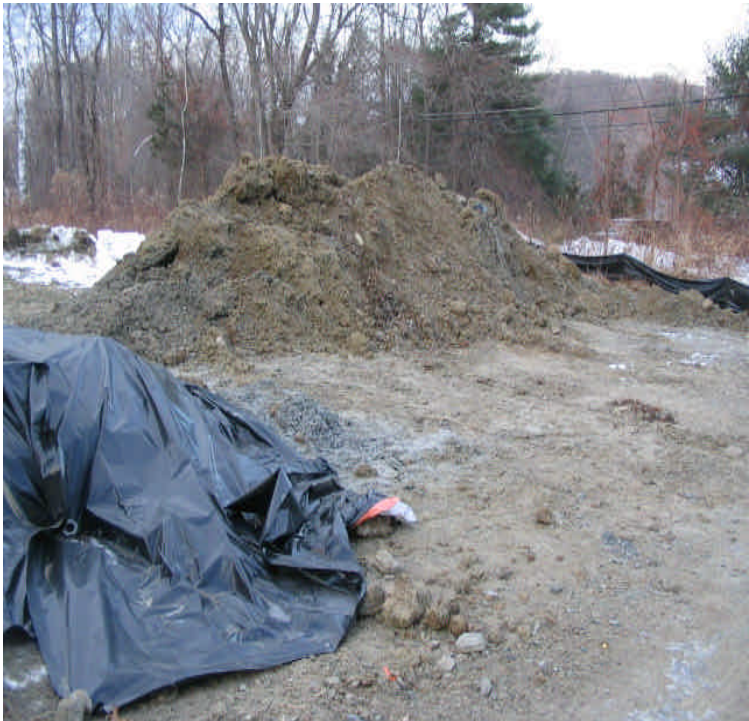
(345kV H-Frame Section): Photo on the left shows a stockpile resulting from a foundation installation off Chestnut Ridge Rd. Photo on the right shows the major clearing that is occurring along the ROW near the Bethel Reservoir. 12/22/05

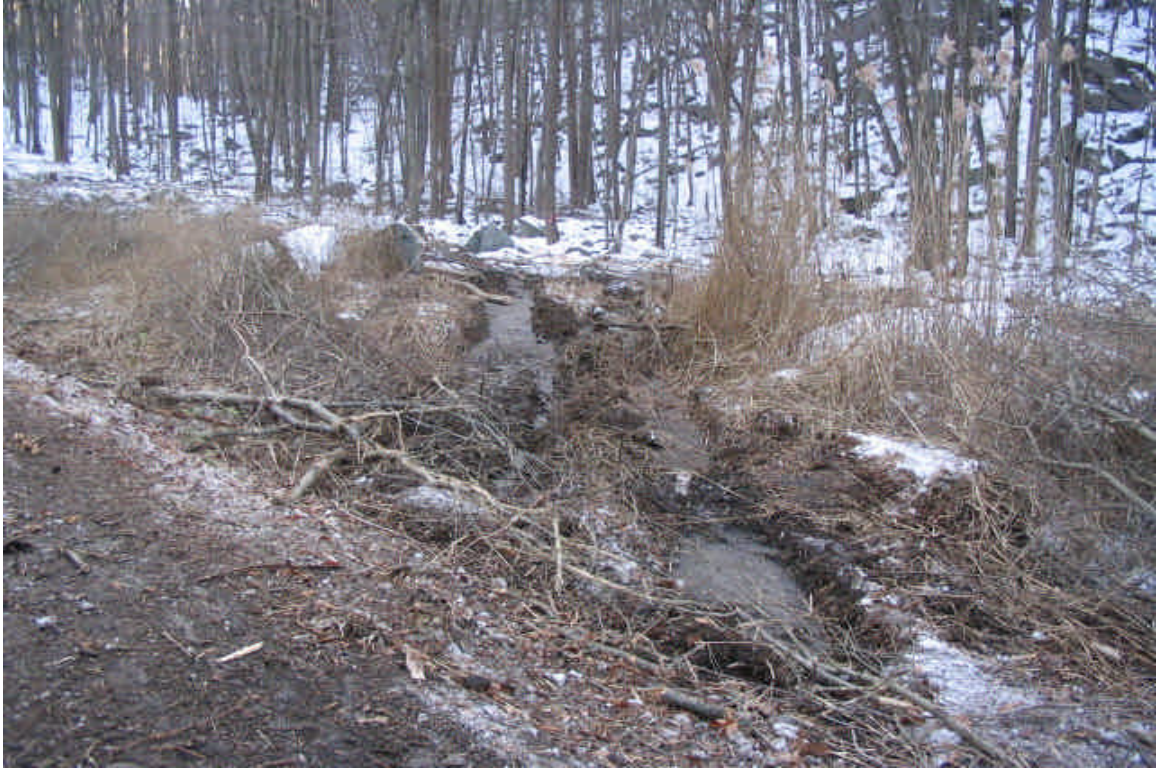
Areas of Inspection	Observation	Recommended Action
	<p>running clear. 12/22/05</p> <p>- A wetland area was damaged by equipment tracking in order to access cleared trees.</p>	<p>- Its should be confirmed whether mats will be used for this purpose in wetlands from now on. 12/22/05</p>
State species of concern, threatened and endangered species	<p>- The composite portion of overhead work includes state-listed turtle habitat area. 9/15-12/22/05.</p> <p>-The Eastern box turtle has not been observed since the first sighting and are likely in the process of hibernating. 12/22/05.</p>	<p>-Turtles would no longer be active at this time of year. 12/22/05</p>
Vegetative clearing limits (including trees to save or danger trees noted)	<p>- Some minor clearing was noted along the access road on the composite section of the ROW, likely for the line pulling. 12/22/05</p> <p>- A large amount of clearing is underway for the H-frame section. Smaller trees and brush are being chipped on site (some chips will be removed) and larger trees may be utilized by landowners. 12/22/05</p>	<p>- None at this time. 12/22/05</p> <p>-Keep clearing to what is necessary. The D&M plan states low growing shrubs can remain. 12/22/05</p> <p>- Do not leave chips on the ROW to a depth of more than 3" and do not place any in wetland areas. 12/22/05</p>

View of some tracking that had occurred in a wetland area in order to access some trees that needed to be cleared. We recommend that the trees are accessed and skidded out through wetlands on swamp mats. 12/22/05

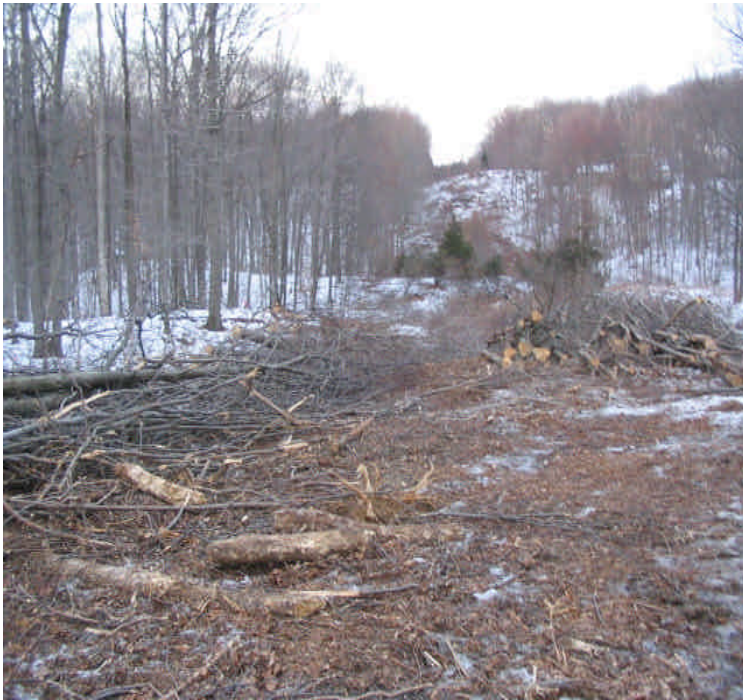
Photo on the left is an additional view of the clearing for the ROW work. Photo on the right is a view of a good swamp mat crossing created over a small stream and wetlands for the access road into the ROW. 12/22/05
